A Laboratory Study of the Stability of Sand-Filled Nylon Bag Breakwater Structures

Robert Ray

MISCELLANEOUS REPORT NO. 77-4
MARCH 1977

U.S. ARMY, CORPS OF ENGINEERS
COASTAL ENGINEERING
RESEARCH CENTER

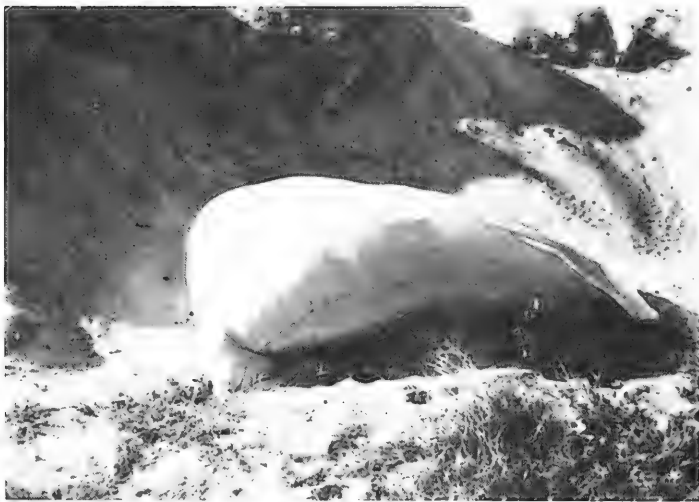
Uncoated or unprotected white nylon deteriorates under exposure to sunlight, specifically ultraviolet light. By the spring of 1967, several field installations of protective revetments had been built of bags and subjected to exposure damage. An estimate of the lifespan of nylon sandbags exposed to the weather (protected from vandalism and wave action) was needed for comparison with the performance of alternate construction materials. A single bag was filled with sand and left on a sandpile exposed to the weather from April 1967 to September 1968 (Fig. 1). Periodically, the bag was probed with the toe of a shoe to test the condition of the material. Between October 1967 and the end of the test, the bag split open along the length of the upper face, evidently due to photochemical (actinic) deterioration of the nylon filaments (Fig. 2).

Figure 1. Sandbag exposed to sunlight, October 1967.

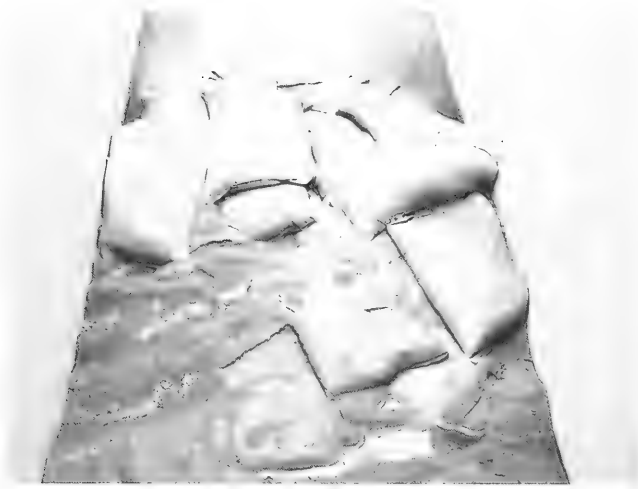
base of the structure during condition c was moved back during condition d, forming mounds at both toes of the structure (Figs. 17, 18, and 19) and flattening the front slope, but causing no change in crest elevation. Wave-induced changes in the structure were small compared to the disruption when the tank was drained.

Figure 17. Front face at end of test I.

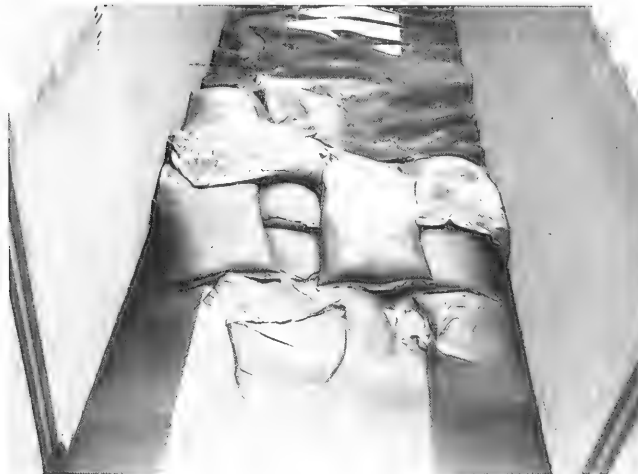
Figure 18. Backface at end of test I.

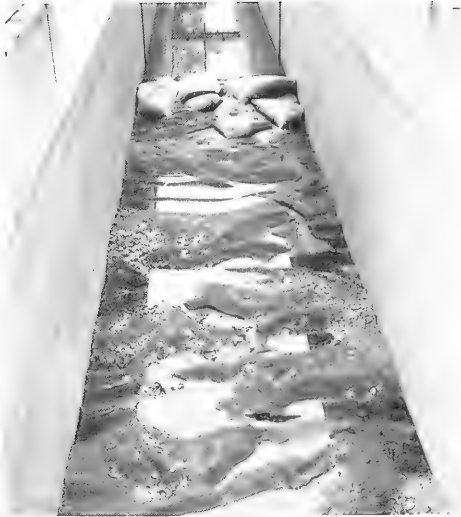
Figure 19. Sand bed to seaward at end of test I.

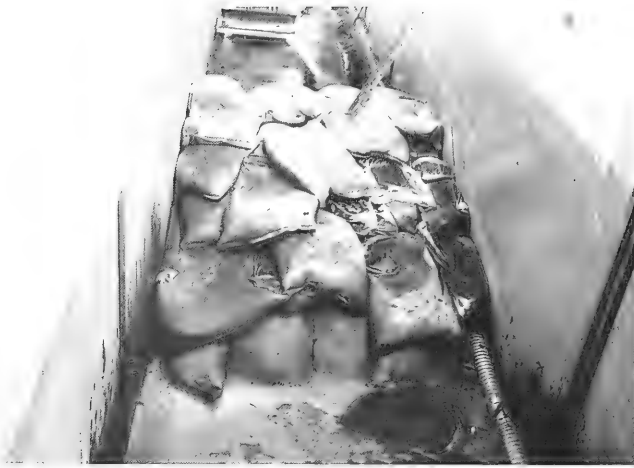
Figure 25. Backface and damaged bags at end of test II.

Both damaged and undamaged bags displayed forms of instability under wave action. Sand was "sucked out" of torn bags until the bags were nearly empty. Evidently, this loss of sand contributed to the settlement during tests I and II. Damaged bags were found in every structure, usually lying in the installed position, implying that the bags were torn during placement. Undamaged bags included even those bags that were displaced suddenly from the crests of the structures to the sand bed. Most changes in the structures were due to movement of undamaged bags. The nylon material was slippery and trapped air, which added buoyancy to the bags, formed cushioning bubbles on the tops and side, and prevented adequate interlocking despite the carefully overlapped layers.

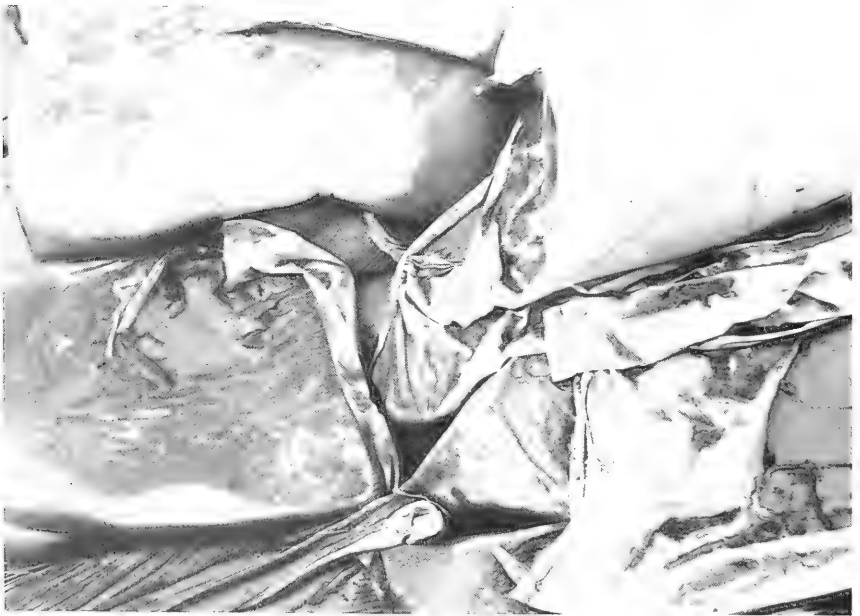
Figure 26. Damaged bags at end of test II.

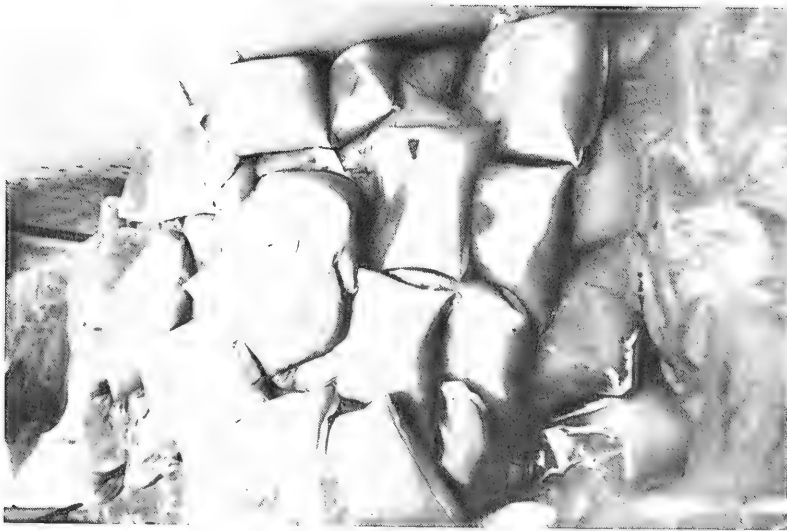
c. Structure Changes. During wave condition a the top layer of bags was displaced off the structure crest, the backface slumped and the front face settled, resulting in a decrease in crest elevation, an increase in crest width, and a flattening of both slopes despite scour at the rear toe (Fig. 24). Changes during wave condition b were negligible. Although more scour occurred at both toes during wave condition c, bags in the backface were displaced off the structure or, if damaged, stayed in place and leaked sand, flattening the back slope. The front face settled and bags from the crest were displaced onto it, flattening the front slope, widening the crest, and lowering the crest elevation. Wave condition d caused accretion of sand at the front toe, but the lower half of the front face settled, steepening the front slope slightly. No change in elevation occurred. After completion of test II, two torn and empty bags were discovered on the crest of the structure (Figs. 25 and 26) and large sand ripples were observed in the sand bed indicating active sand movement (Figs. 27 and 28).

Figure 27. Front face at end of test II.

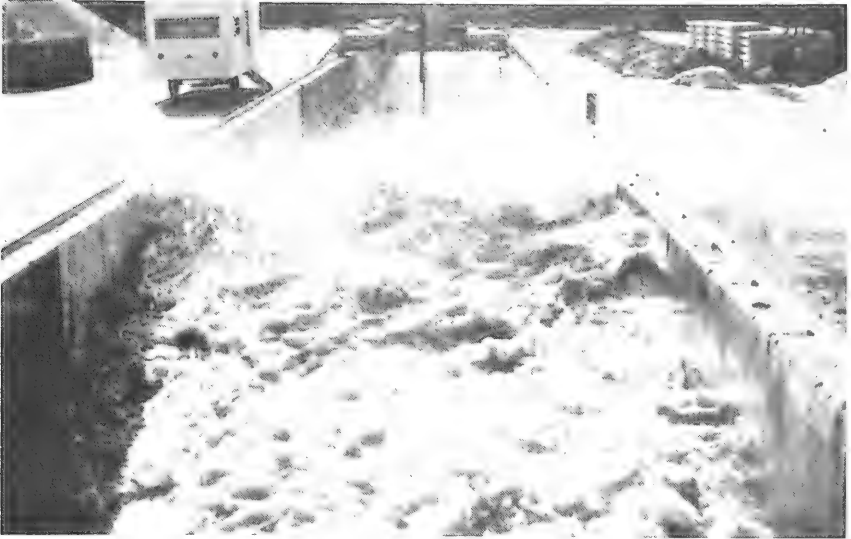
Figure 43. Wave breaking on front face after loss of seaward row of bags on breakwater crest during wave condition a (test IV).

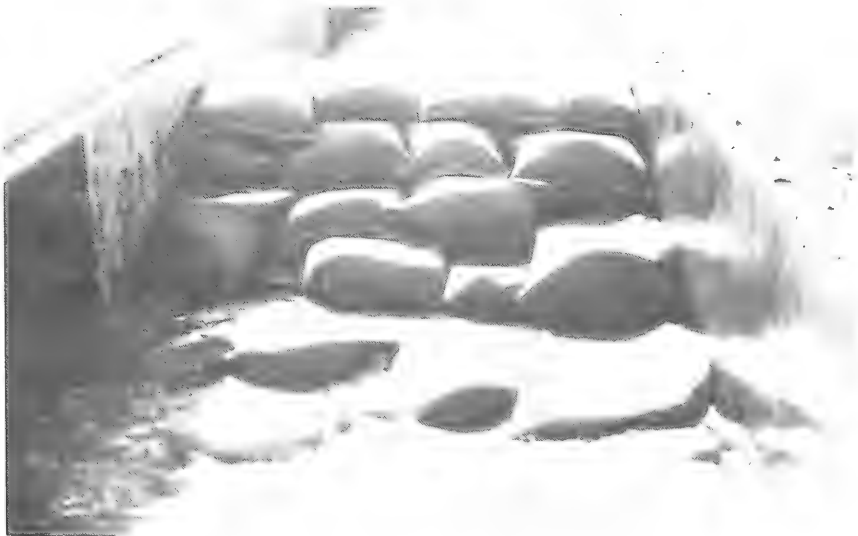
Figure 46. Front face after 50 waves shows seaward row of bags missing from breakwater crest during wave condition a (test IV).

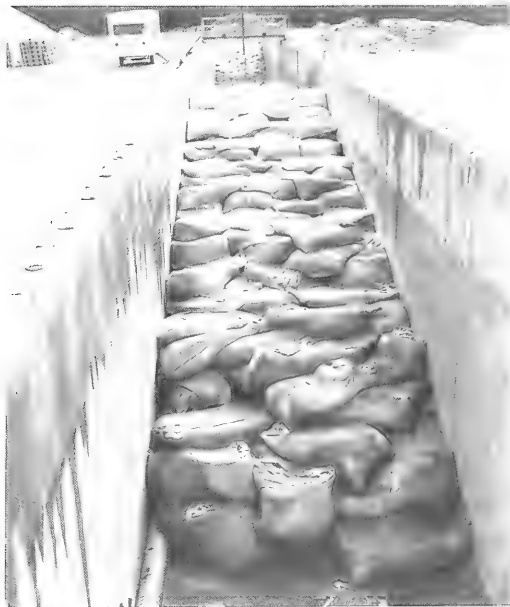
condition c was terminated when all visible movement stopped (Figs. 49 and 50). As experience during tests I, II, and III had shown that wave conditions a and c produced the most significant damage, structure IV was not subjected to wave condition d. The sand bed beyond the toes of the structure was not surveyed in test IV, but when the tank was drained at the end of the test, only slight changes in the sand bed were observed.

Figure 49. Front face at end of test IV.
